TECHNICAL REPORT 4357

THE EFFECTS OF LONG TERM STORAGE ON SPECIAL PURPOSE LEAD AZIDE

Technical Report 4357

Explosives Division
Feltman Research Laboratory
Picatinny Arsenal
Dover, N. J.

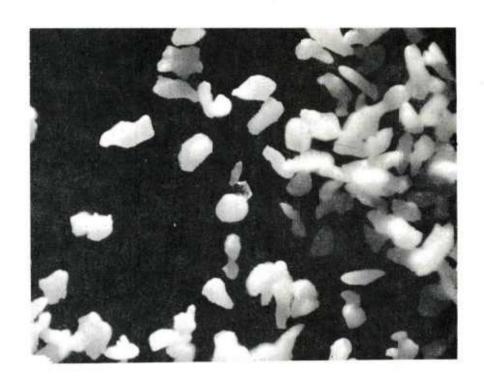
SPLA Lot #Dup-53-17 9/25/69 1st Cycle SPLA Lot #0M-67-5 9/25/69 1st Cycle Fig 12

Military specifications require that production lead azide (SPLA and RD 1333) contain no well defined crystalline material if observed through a microscope. With a few exceptions, photomicrographs taken of SPLA and RD 1333, as received from storage, show satisfactory agreement with this requirement (Fig 11). However, following each temperature cycle the photomicrographs indicate the appearance of small crystallites and, in some cases, the growth of clear crystalline material on the lead azide particles. Fig 12 and 13 demonstrate the clarity and show the well-defined crystalline faces of the crystallites. It should be emphasized, however, that the number of the crystallites is not large. (These photomicrographs were chosen specifically to indicate the nature and morphology of the crystallites and are not indicative of their concentration.)

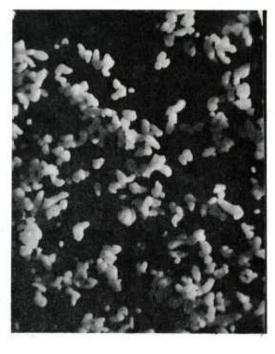
and are under way for the second group. Of the 18 samples examined and photographed for the first surveillance group only two showed any signs of abnormality. One sample (Lot JA 4-71) contained numerous small rounded particles not seen in any of the other samples tested to date. The rounded form of the particles would indicate that they were formed during precipitation in the presence of the crystal modifier. The other sample (Lot JA 4-76) contained a large number of crystals with a spinelike growth that appears to be crystalline. In the impact sensitivity tests or assay analysis, neither of these samples exhibited any abnormalities that might indicate an undesirable situation, and both were colorless to the eye. Photomicrographs of these samples are shown in Fig 19. It was decided that the rounded particles, although abnormal, were inconsequential and should provoke no great concern. However, the possibility exists that the spinelike growths seen are the results of recrystallization, making their appearance consequential, regardless of the test results.

JA-4-71 X 40

JA-4-71 X 100

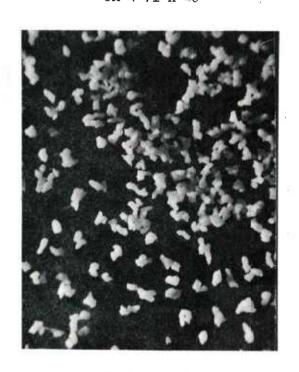
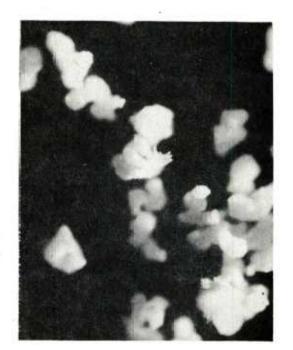
Figure 19

JA-4-76 X 40

JA-4-76 X 100
